Lower American River River Mile 1.8L Bank Protection Project

5th Annual Report 2010

**Sacramento
Area Flood
Control
Agency**

December 2010

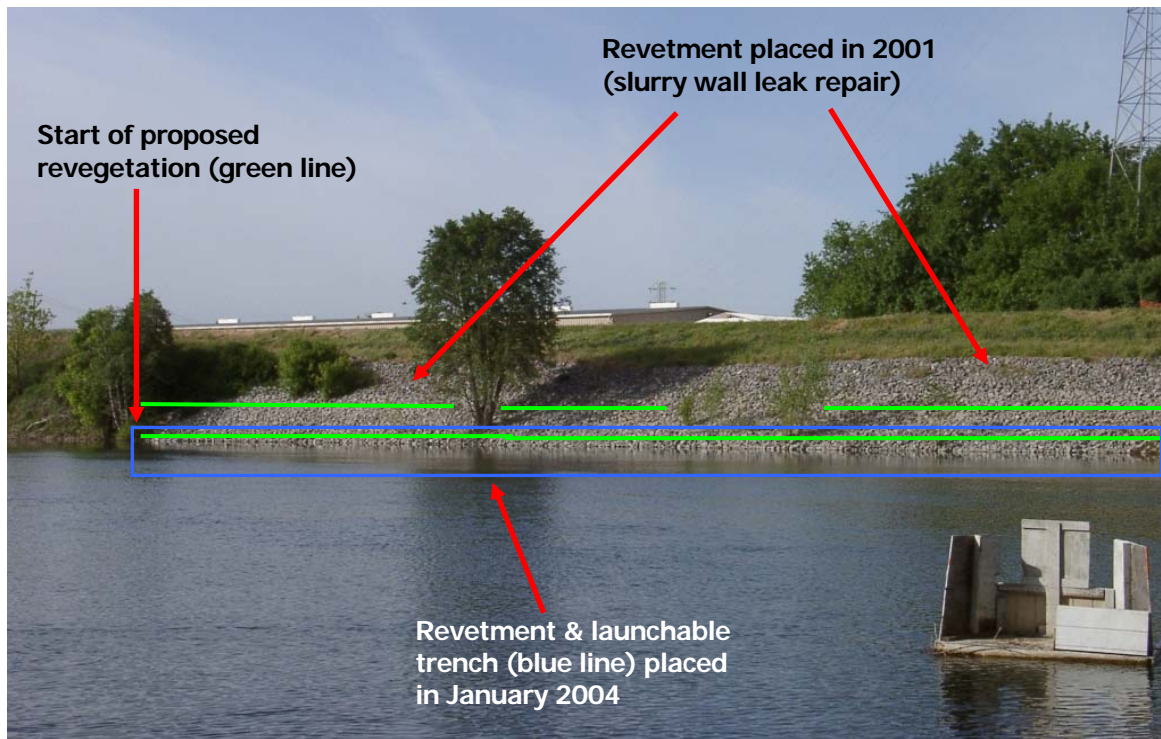
In late 2003/early 2004, SAFCA added additional protection to the site by installing approximately 10,000 tons of riprap along 750 feet of the levee toe below the ordinary high water mark (Figure 1). Vegetation within the area was limited to the sparse riparian vegetation that was not removed during the 2001 construction or that re-established following the Corps' repair work.

Figure 1 – Existing conditions at upstream end of site

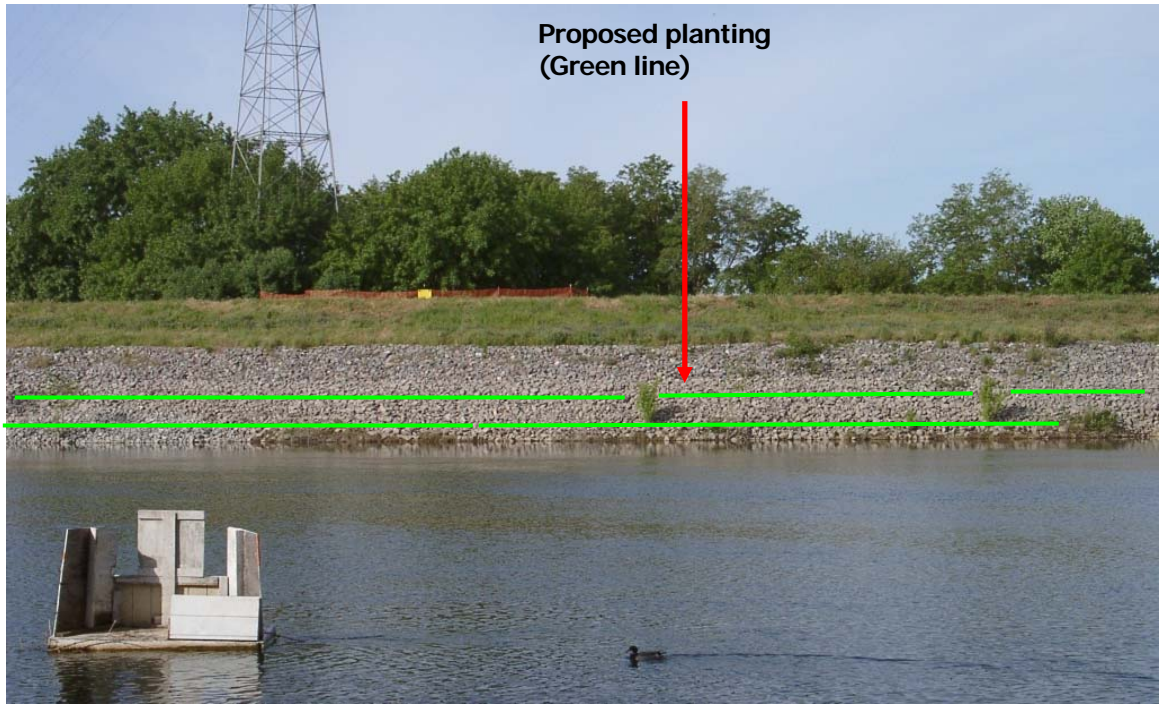
Figure 2 – Pre-project conditions at mid section of RM 1.8L.

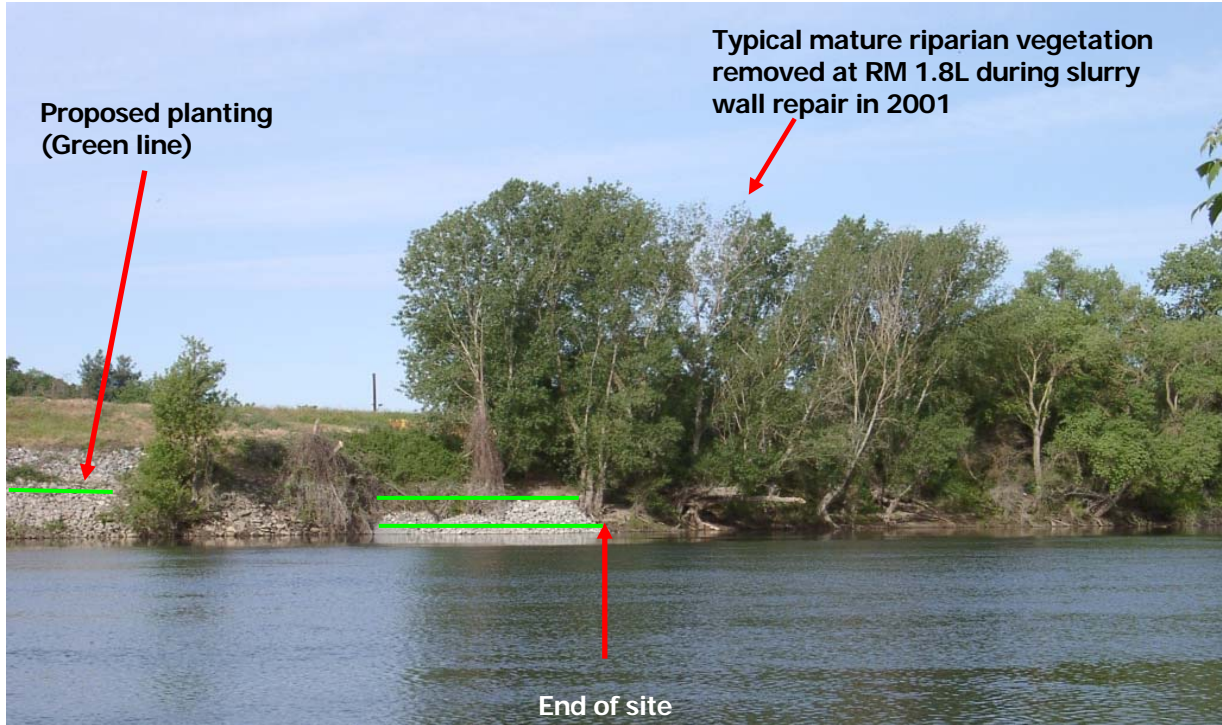
Prior to the levee fracture and subsequent reconstruction of the levee in 2001, the site was heavily vegetated with trees and shrubs similar to the existing conditions at the downstream end of the site (Figure 3). SAFCA’s revegetation plan replaced a portion of the vegetation that was present at the site prior to 2001. It was therefore assumed there would be no increase in water surface elevations, or change in velocity distribution, or magnitude as a result of implementing the revegetation plan and a hydraulic analysis was not conducted.

Figure 3 – Mature riparian SRA – existing conditions at downstream end of RM 1.8L.
