Lower American River
River Mile 1.8L Bank Protection Project

Monitoring Report – 2007 (Year 2)

Sacramento Area Flood Control Agency
1007 7th Street, 7th Floor
Sacramento, CA 95814
(916) 847-7606
Contact: Peter E.F. Buck

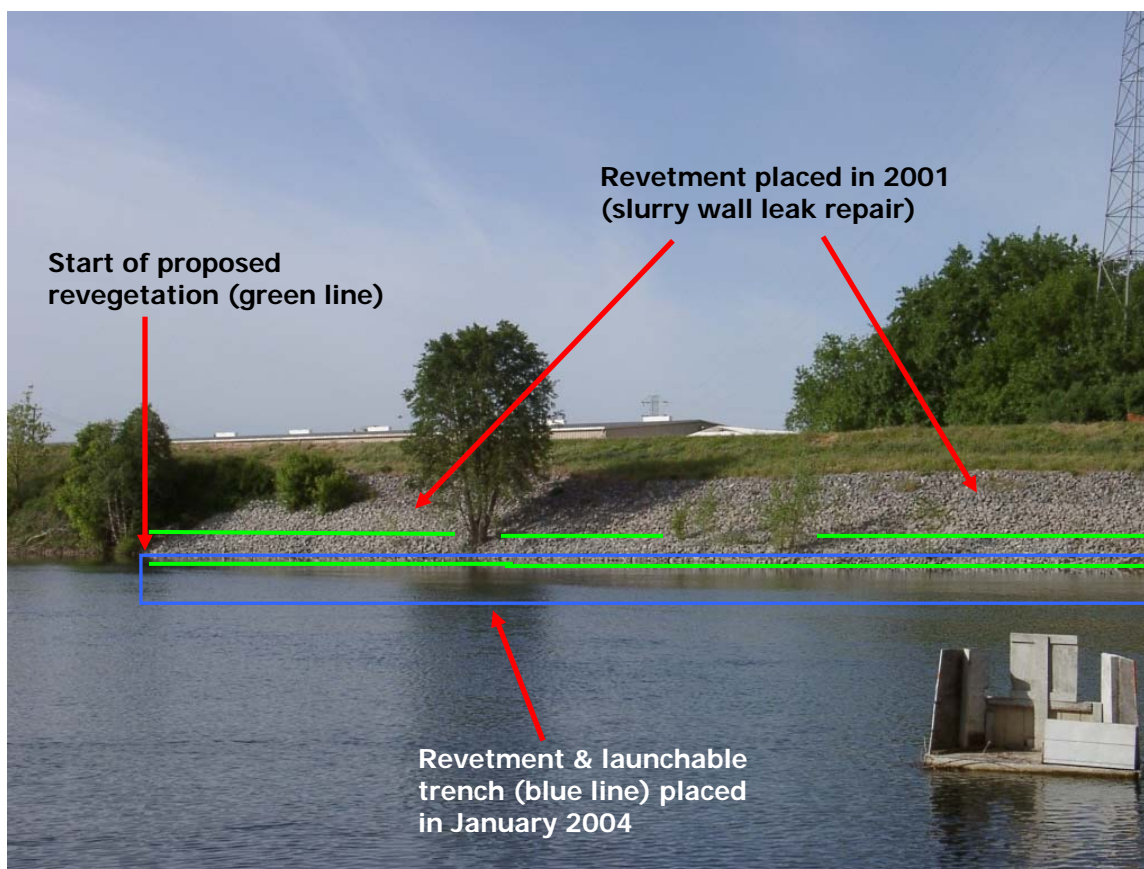
River mile 1.8L has experienced erosion over the years and has been treated with varying types of rubble revetment. Much of this rubble has slid into the channel and has now been removed and the levee covered with angular riprap (Figure 1).

Figure 1 RM 1.8L - Existing conditions at upstream end of site

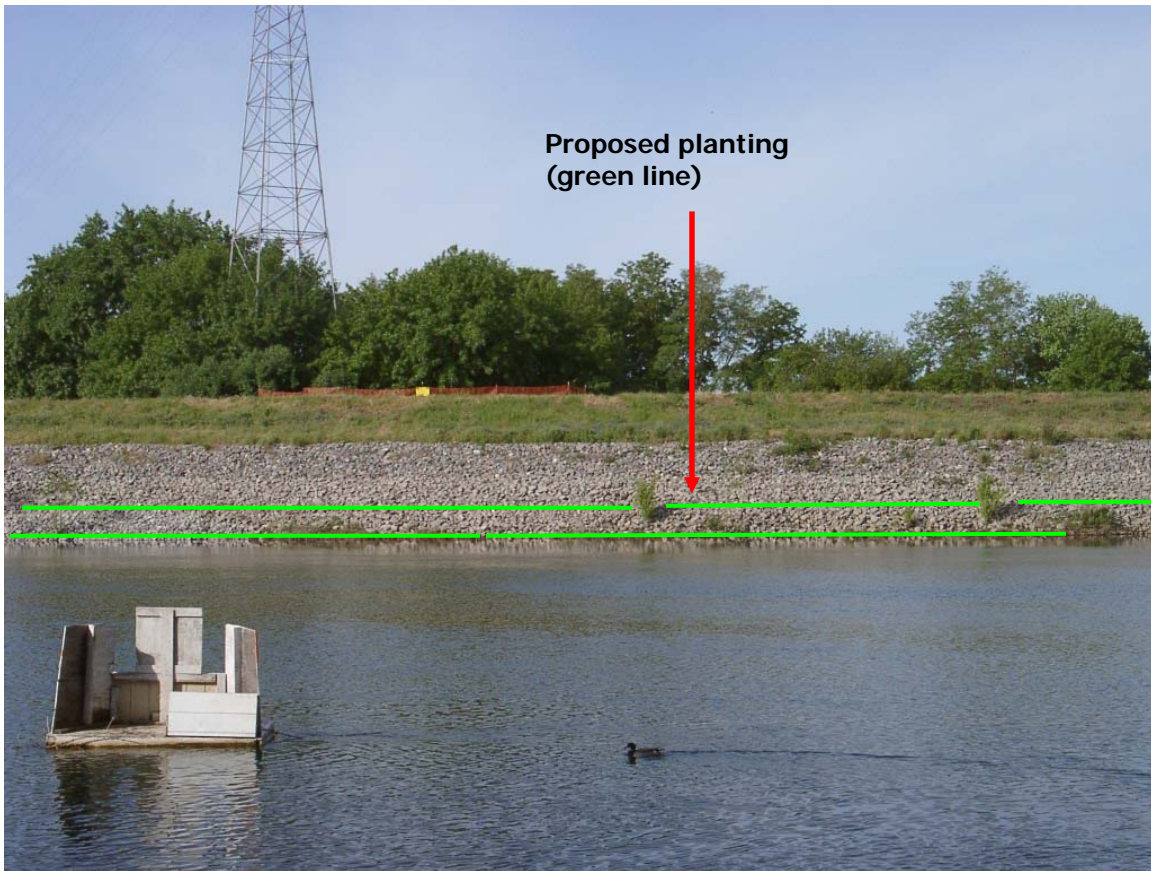
The revegetation design consists of two rows of woody vegetation along the bottom one third of the revetment site. The rows were planted 16 feet apart and trees were spaced at 12 ft centers. Scattered shrubs were planted in between the parallel rows (Figure 2) in addition to a band of herbaceous plants at the waterline. Vegetation has been and will continue to be intensively irrigated with an above ground irrigation system, which will be installed at the beginning of the growing season (April) and removed prior to the onset of the flood season (end of October). Intensive weeding and irrigation will be conducted for a three-year establishment period. A summary of the revegetation plan including cross sectional drawings and the proposed planting palette is attached as Exhibit A.

Figure 2 RM 1.8L – existing conditions at mid section of site

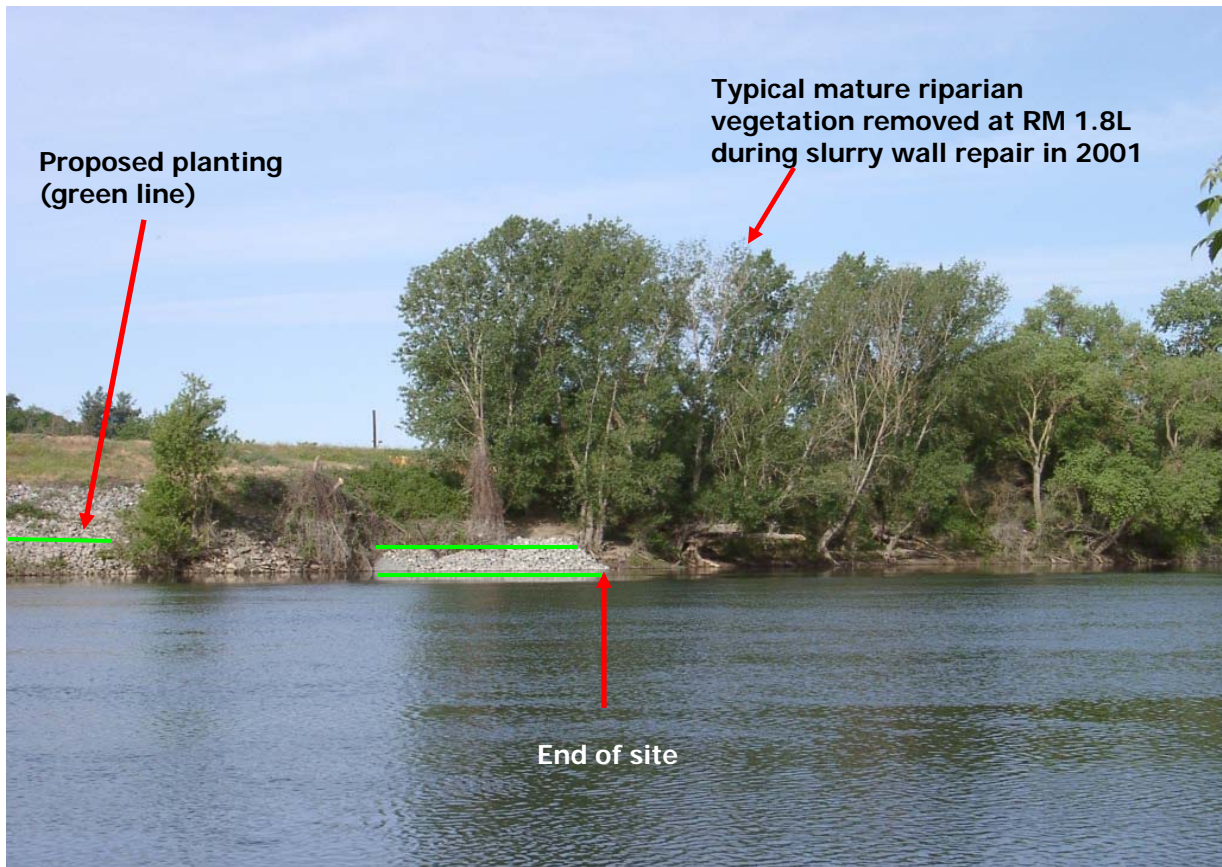
Figure 3 Mature riparian SRA – existing conditions at downstream end of site

A detailed hydraulic analysis of the revegetation plan has not been conducted. Prior to the levee fracture and subsequent reconstruction of the levee, the site was heavily vegetated with trees and shrubs similar to the existing conditions at the downstream end of the site (Figure 3). SAFCA’s revegetation plan replaced a portion of the vegetation that was previously present at the site. It was therefore assumed there would be no increase in water surface elevations, or change in velocity distribution, or magnitude as a result of implementing the revegetation plan.
