**Lower American River  
River Mile 1.8L Bank Protection Project**

**Monitoring Report – 2008 (Year 3)**

**Sacramento Area Flood Control Agency  
1007 7<sup>th</sup> Street, 7<sup>th</sup> Floor  
Sacramento, CA 95814  
(916) 874-6451  
Contact: Lizette Crosbie**

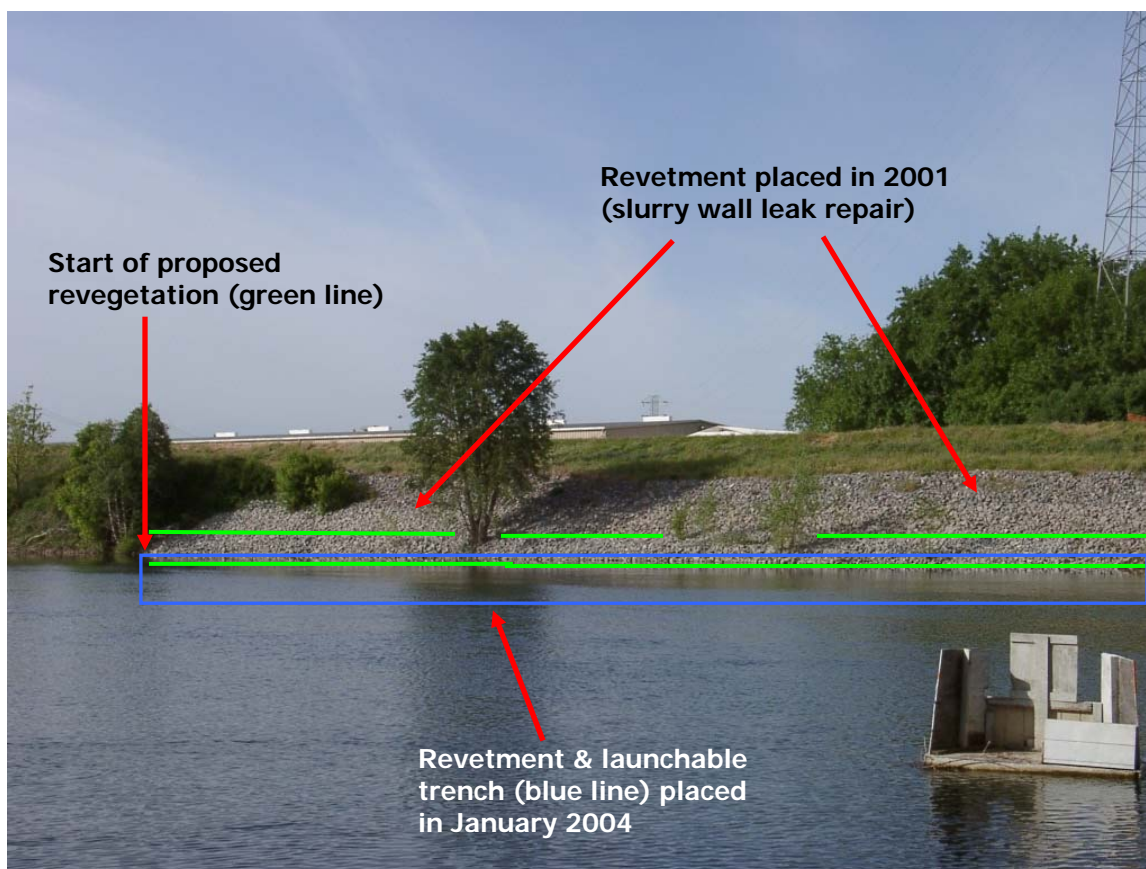
River mile 1.8L has experienced erosion over the years and has been treated with varying types of rubble revetment. Much of this rubble has slid into the channel and has now been removed and the levee covered with angular riprap (Figure 1).

**Figure 1 RM 1.8L - Existing conditions at upstream end of site**

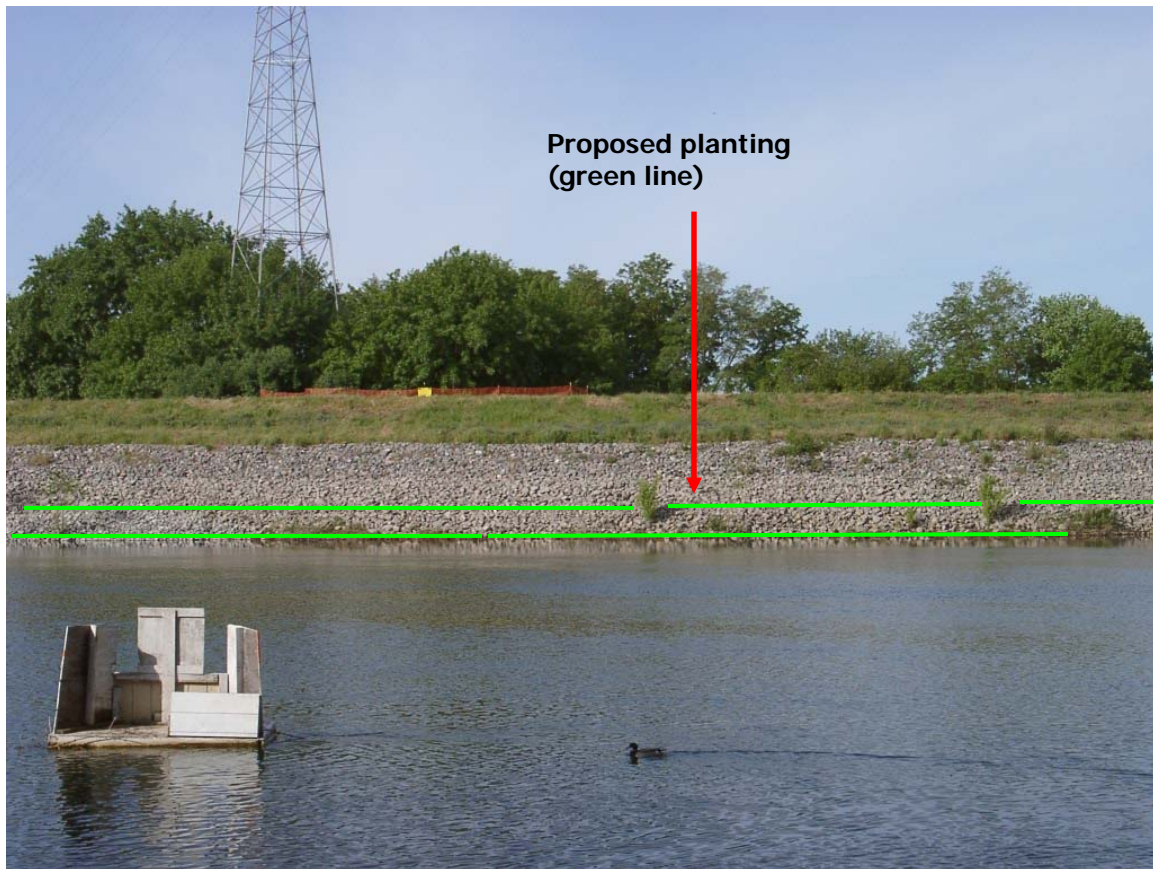
The revegetation design consists of two rows of woody vegetation along the bottom one third of the revetment site. The rows were planted 16 feet apart and trees were spaced at 12 ft centers. Scattered shrubs were planted in between the parallel rows (Figure 2) in addition to a band of herbaceous plants at the waterline. Vegetation has been and will continue to be intensively irrigated with an above ground irrigation system, which is installed at the beginning of the growing season (April) and then removed prior to the onset of the flood season (end of October). Intensive weeding and irrigation will be conducted for a three-year establishment period. A summary of the revegetation plan including cross sectional drawings and the proposed planting palette is attached as Exhibit A.

Figure 2 RM 1.8L – existing conditions at mid section of site

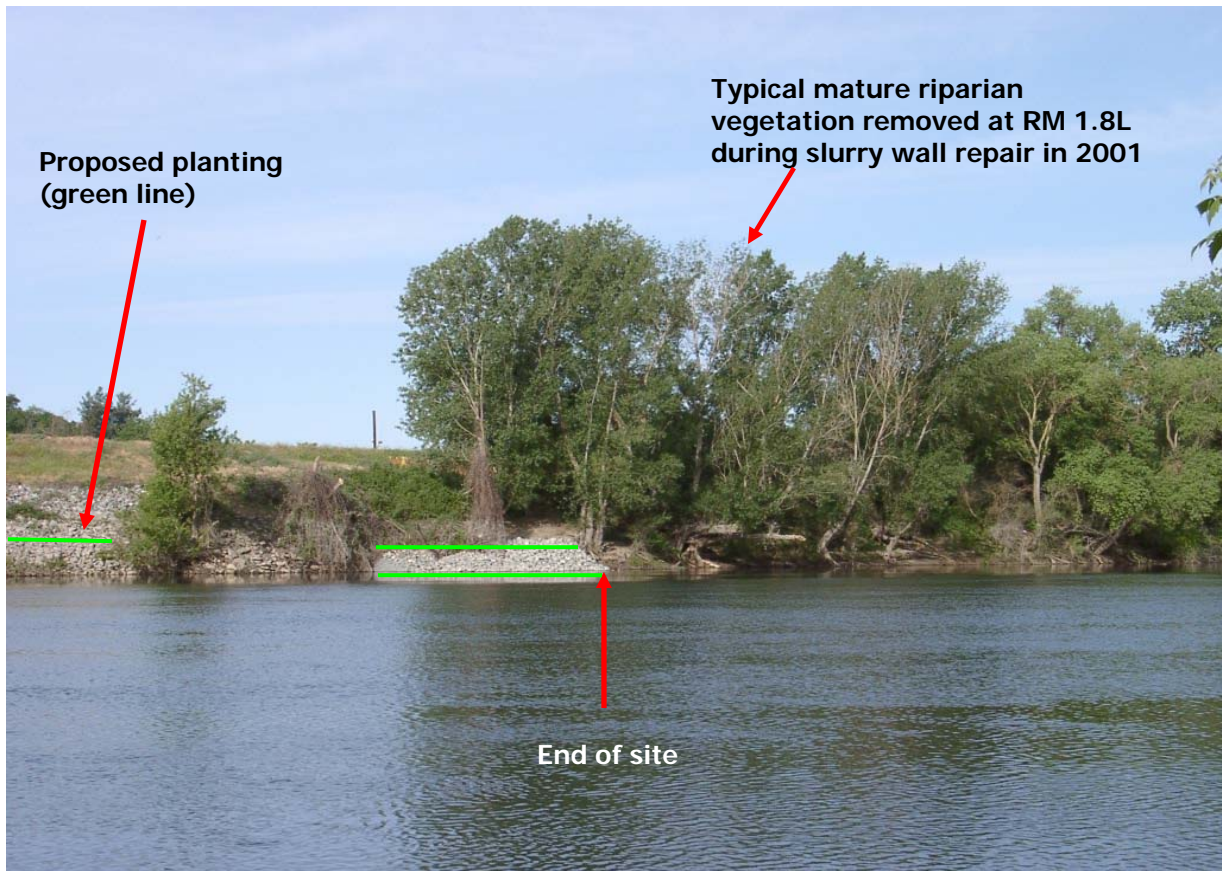
**Figure 3 Mature riparian SRA – existing conditions at downstream end of site**

A detailed hydraulic analysis of the revegetation plan has not been conducted. Prior to the levee fracture and subsequent reconstruction of the levee, the site was heavily vegetated with trees and shrubs similar to the existing conditions at the downstream end of the site (Figure 3). SAFCA's revegetation plan replaced a portion of the vegetation that was previously present at the site. It was therefore assumed there would be no increase in water surface elevations, or change in velocity distribution, or magnitude as a result of implementing the revegetation plan.
