Lower American River River Mile 1.8L Bank Protection Project

4th Annual Report 2009

**Sacramento
Area Flood
Control
Agency**

January 2010

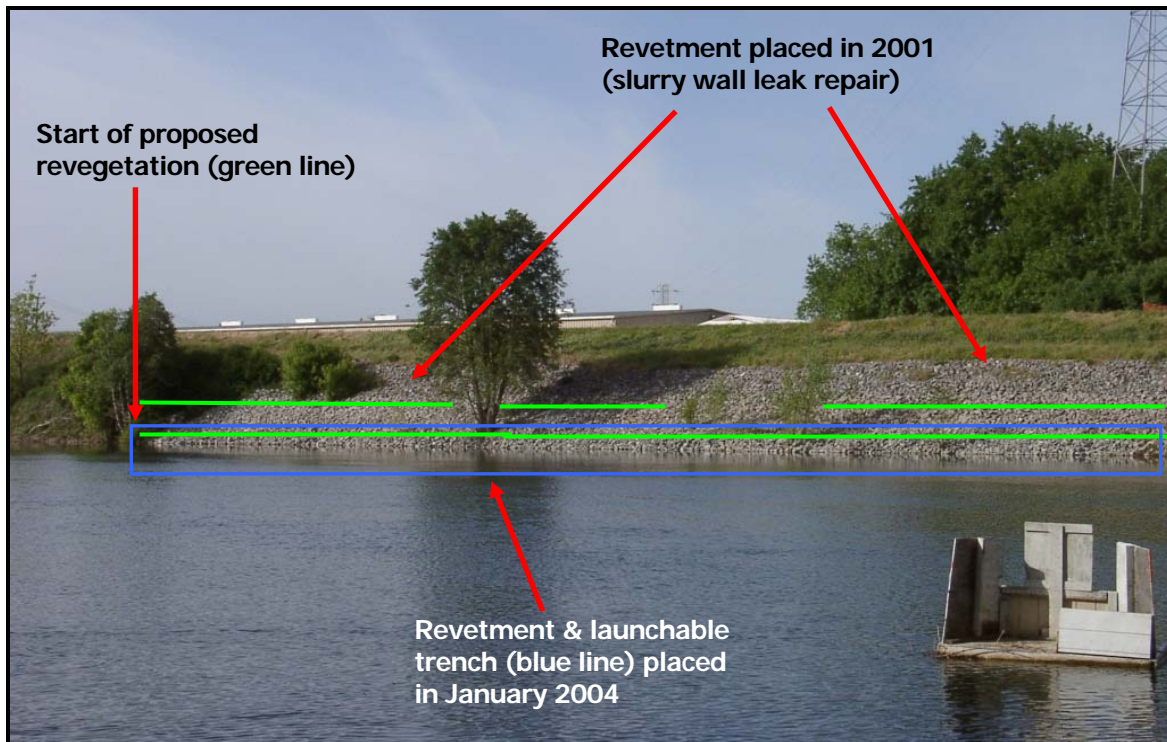
In late 2003/early 2004, SAFCA added additional protection to the site by installing approximately 10,000 tons of riprap along 750 feet of the levee toe below the ordinary high water mark (Figure 1). Vegetation within the area was limited to the sparse riparian vegetation that was not removed during the 2001 construction or that re-established following the Corps' repair work.

Figure 1 – Existing conditions at upstream end of site

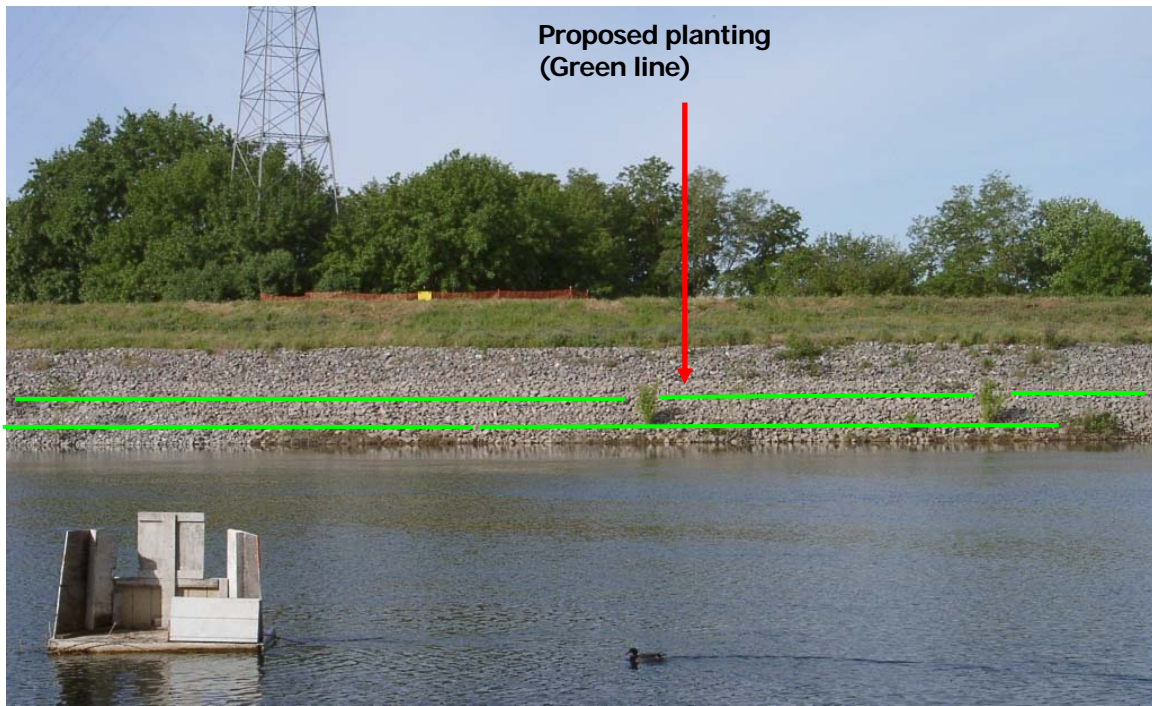
Figure 2 – Pre-project conditions at mid section of RM 1.8L.

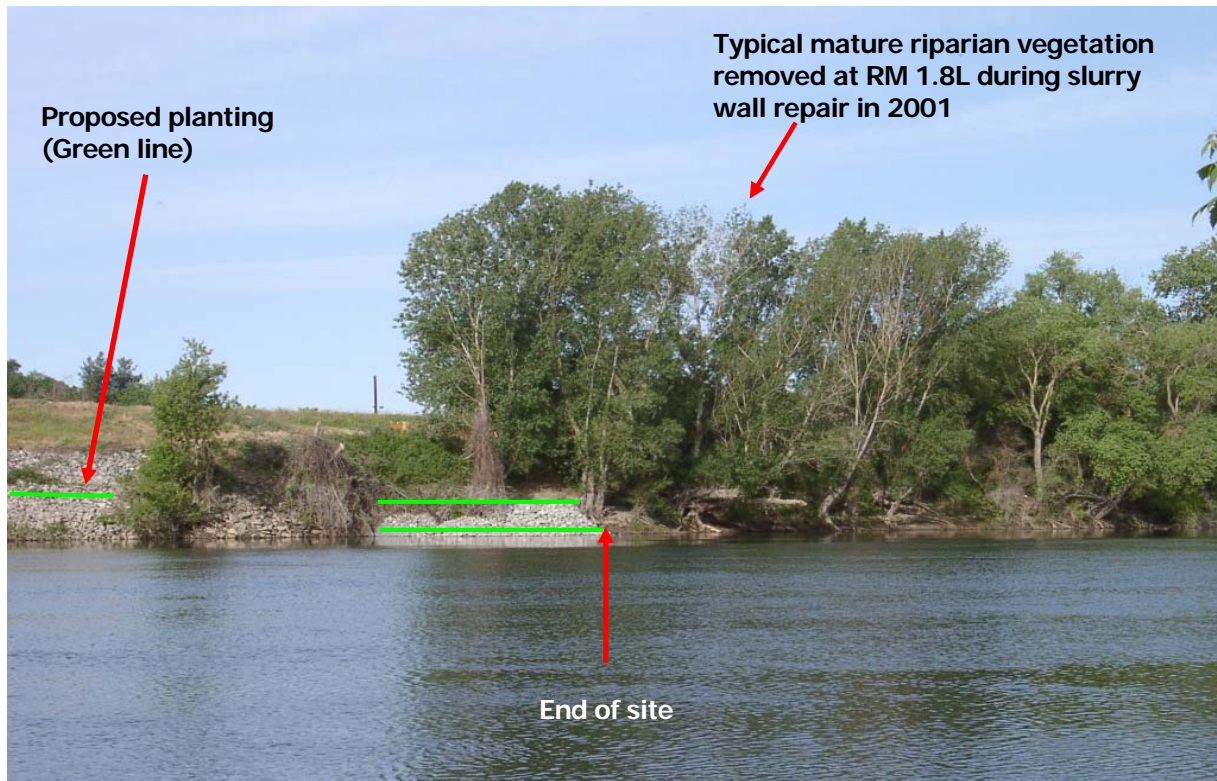
Prior to the levee fracture and subsequent reconstruction of the levee in 2001, the site was heavily vegetated with trees and shrubs similar to the existing conditions at the downstream end of the site (Figure 3). SAFCA’s revegetation plan replaced a portion of the vegetation that was present at the site prior to 2001. It was therefore assumed there would be no increase in water surface elevations, or change in velocity distribution, or magnitude as a result of implementing the revegetation plan and a hydraulic analysis was not conducted.

Figure 3 – Mature riparian SRA – existing conditions at downstream end of RM 1.8L.
