Status of Habitat Mitigation and Monitoring for
Magpie Creek Diversion Channel

Combined Annual Report 2007 & 2008

Sacramento
Area Flood
Control
Agency

March 24, 2009

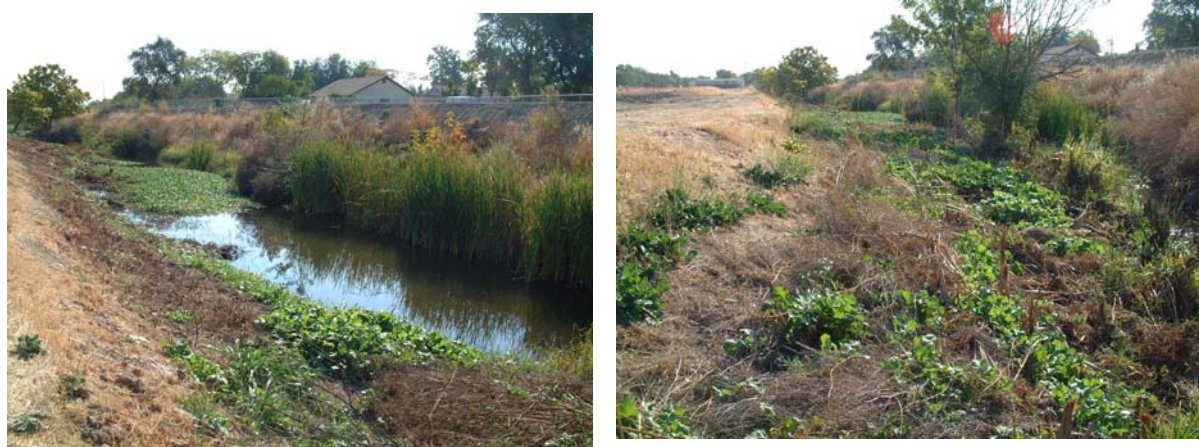
Figure 1 – Old Section of MCDC Prior to Construction

The Magpie Creek Diversion Channel (MCDC) was constructed in 1955 and 1956 by the USACE and the State of California as a flood control channel. The purpose of the USACE project was to provide flood control to the local area by diverting flows away from the lower portion of Magpie Creek into this constructed channel. The channel contained few natural features such as a meander pattern, bank development, riffles, pools, and other morphological features (Figure 1) and is constrained by residential development to the south.

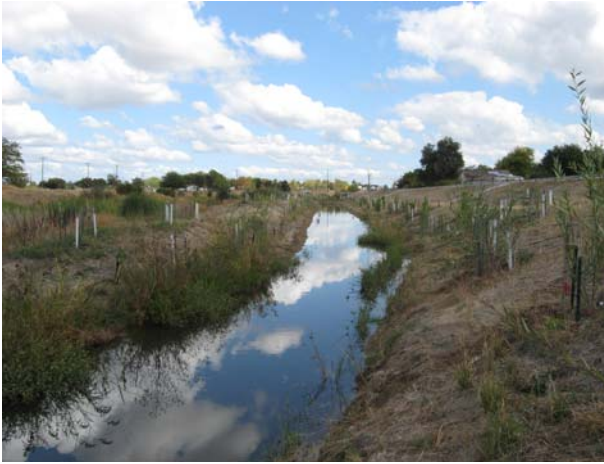
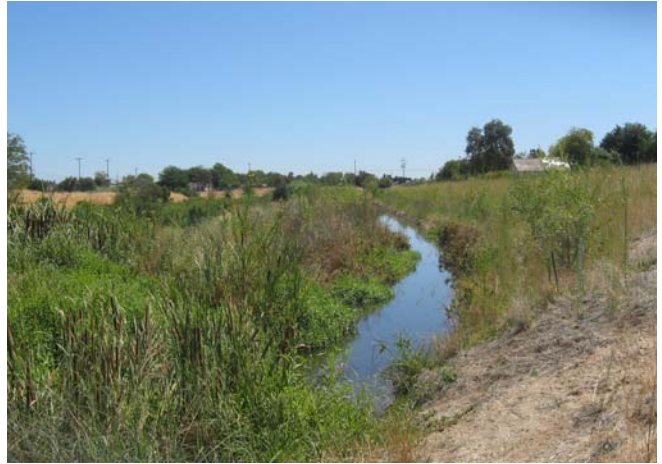
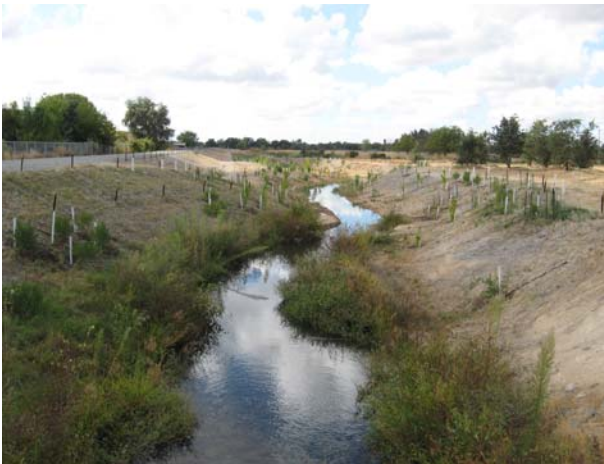
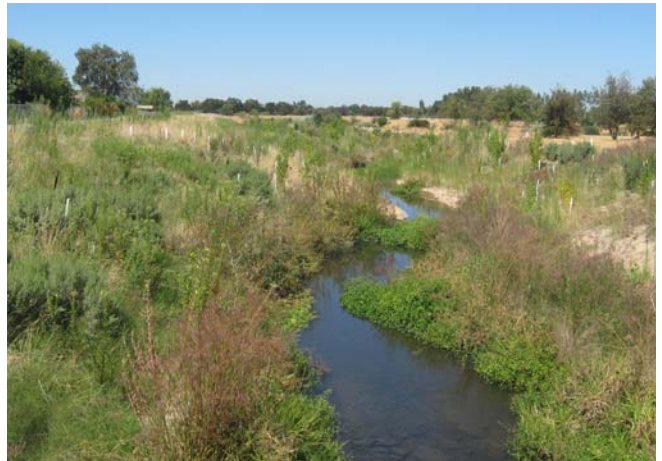
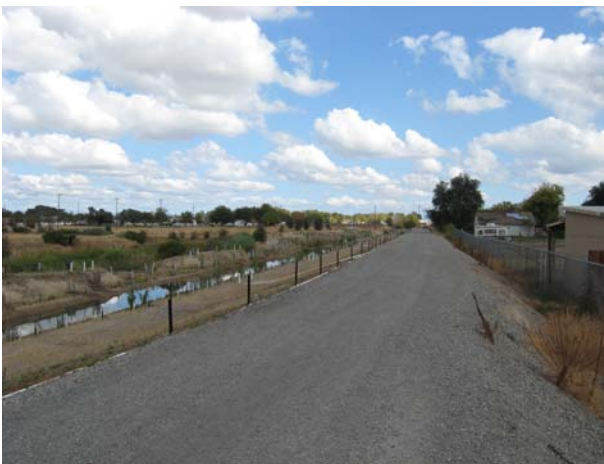
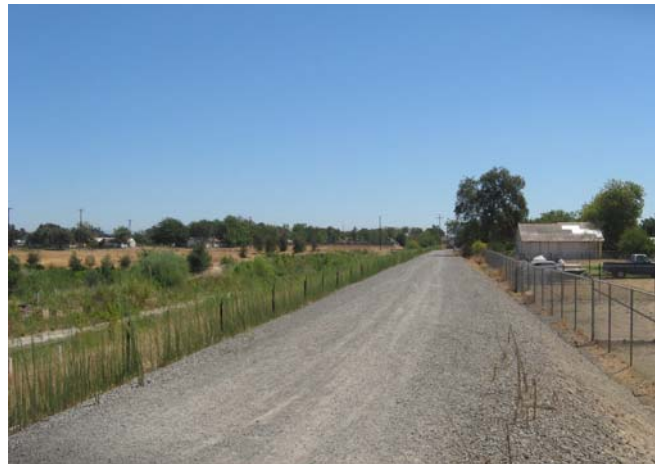
Photographs will be taken annually through the 5th year from permanent locations and will provide photographic documentation of the progress of all restoration and enhancement actions at MCDC.

The stream channel was qualitatively assessed during both 2007 and 2008 and there were no observations of erosion, sedimentation or bank and bed scours. Photopoints of the MCDC can be seen in Appendix D. Wildlife surveys at MCDC have included observations of aquatic wildlife using the open water habitat and terrestrial wildlife utilizing the riparian woodland habitat (see 3.2 Wildlife below). These observations indicate that SAFCA is currently meeting the 5th year performance goals for the open water habitat.
