Status of Habitat Mitigation and Monitoring for  
**Magpie Creek Diversion Channel**

*3<sup>rd</sup>* Annual Report 2009

Sacramento  
Area Flood  
Control  
Agency

December 22, 2009

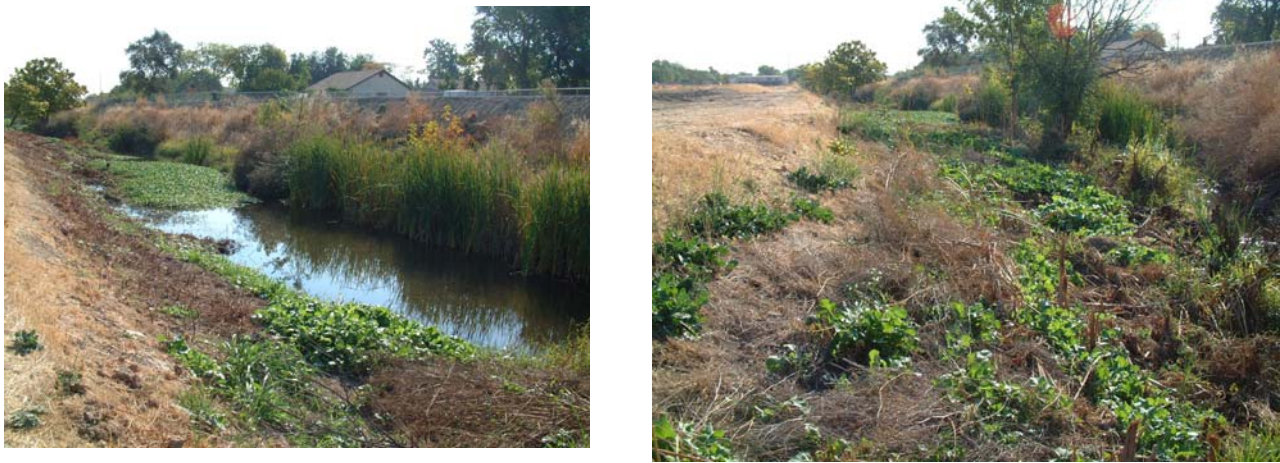
**Figure 1 – Old Section of MCDC Prior to Construction**

During 2002, it was observed that the steep slope of the levee along the south side of the MCDC was eroding. Additionally, the channel was dominated by non-native vegetation and the overall habitat value was low. In an effort to improve the habitat quality and stabilize the upper portion of the left bank, SAFCA proposed this enhancement project. SAFCA considered two alternatives for addressing this levee erosion. The first alternative was the construction of a flood wall to stabilize the levee slope. The second alternative, which was selected by SAFCA, was to flatten the slope of the levee and the channel bank. The project included moving the channel away from the steep levee slope, rebuilding a more gradual slope, and revegetating the riparian corridor with native plant species. The overall goals of the project are summarized below:

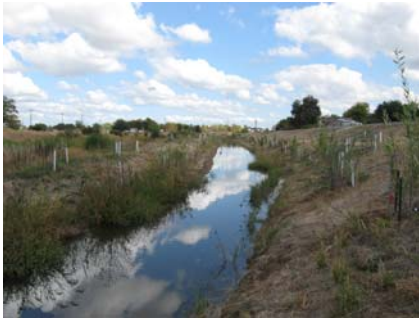
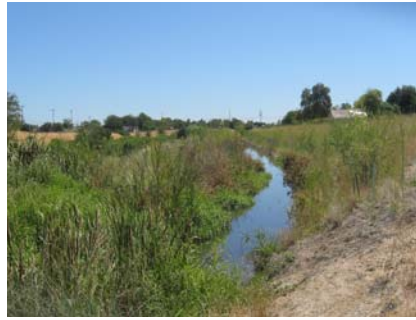
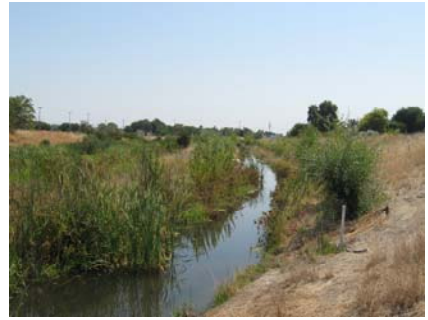
The stream channel has been qualitatively assessed annually since 2007 and there have been no signs of major erosion, sedimentation, or bank and bed scour. However, some locations along the shoreline have remained bare and plants have failed to colonize these areas. During fall 2009, wetland plants and willow cuttings were installed to help enhance the wetland habitat and encourage some sedimentation along these bare areas. Fixed photopoints have been taken

annually to record the growth and success of MCDC over time and can be seen in Appendix D. Observations of aquatic wildlife and terrestrial wildlife during surveys indicate that SAFCA is currently meeting the 5<sup>th</sup> year performance goals for the open water habitat (see 3.2 Wildlife below).
