Status of Habitat Mitigation and Monitoring for
The Rio Linda Creek Conservation Area
Annual Report 2005

February 10, 2006

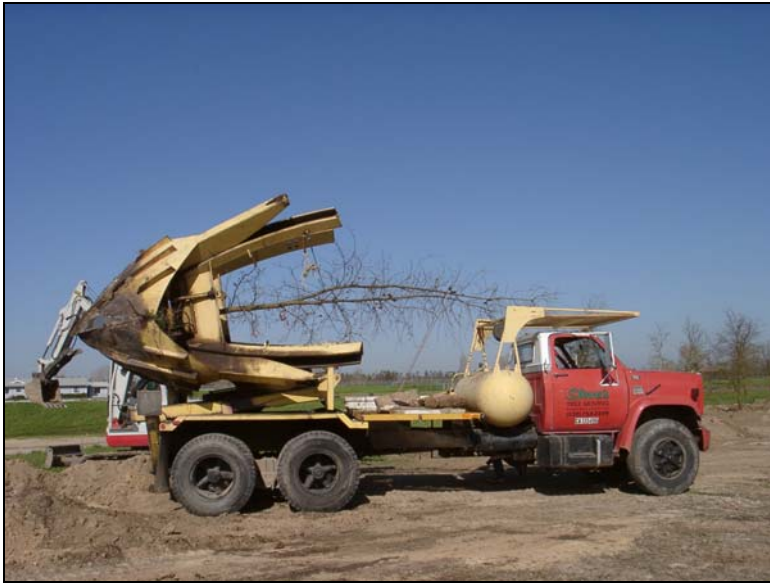
A number of young oak trees were transplanted to the terrace outside of the flood channel in February 2003 (Figure 5). These trees were removed from the Rio Linda airport to resolve aeronautical safety concerns. They are being irrigated and maintained as part of the restoration of the RLCCA.

Figure 5 - Oak tree being transplanted to RLCCA.

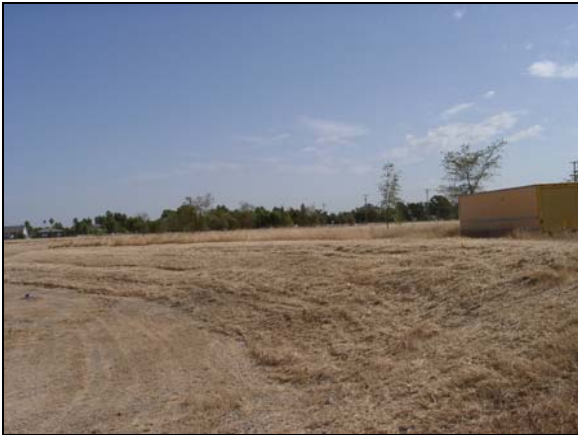
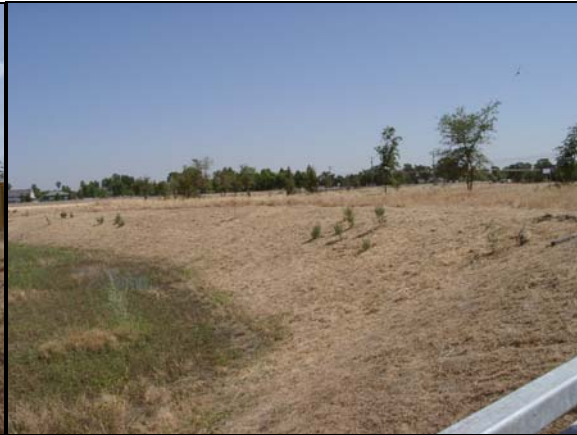
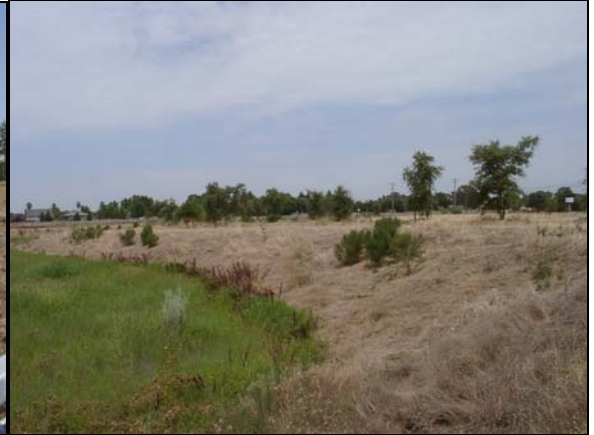
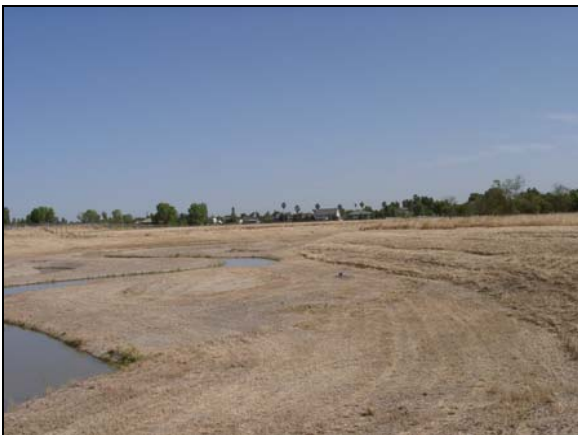
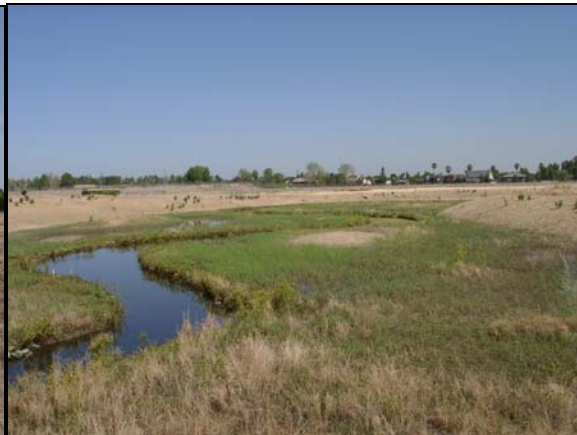
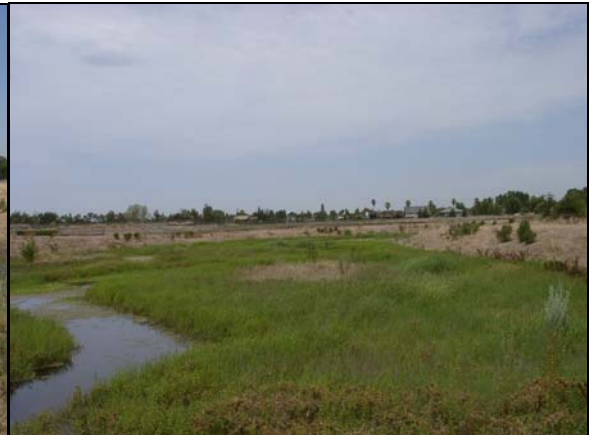
Photopoints of the RLCCA can be seen in Appendix A. By comparing these photos over time, we can monitor erosion and vegetation recovery. It is evident from these photos that the newly constructed stream banks are stable and there does not appear to be any evidence of erosion.
