Status of Habitat Mitigation and Monitoring for
The Rio Linda Creek Conservation Area
Annual Report 2006

January 18, 2007

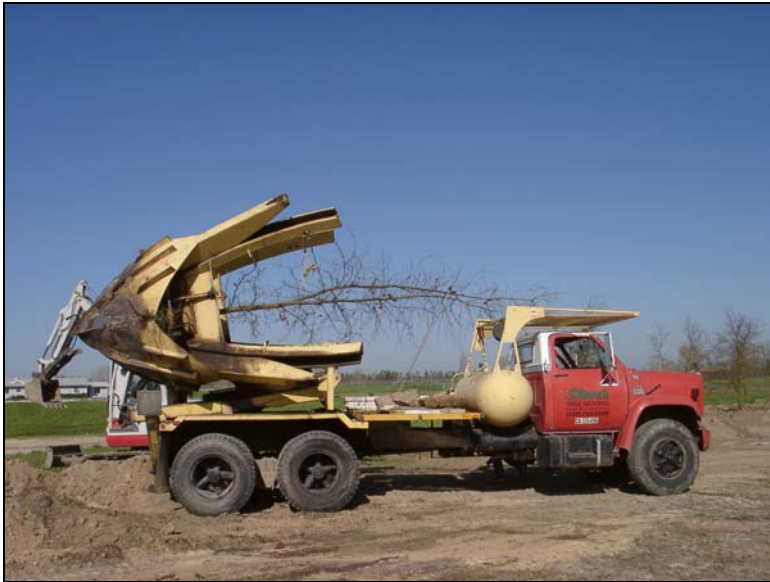
A number of young oak trees were transplanted to the terrace outside of the flood channel in February 2003 (Figure 5). These trees were removed from the Rio Linda airport to resolve aeronautical safety concerns. They are being irrigated and maintained as part of the restoration of the RLCCA.

Figure 5 - Oak tree being transplanted to RLCCA.
