Status of Habitat Mitigation and Monitoring for
The Rio Linda Creek Conservation Area
Annual Report 2007

April 01, 2008

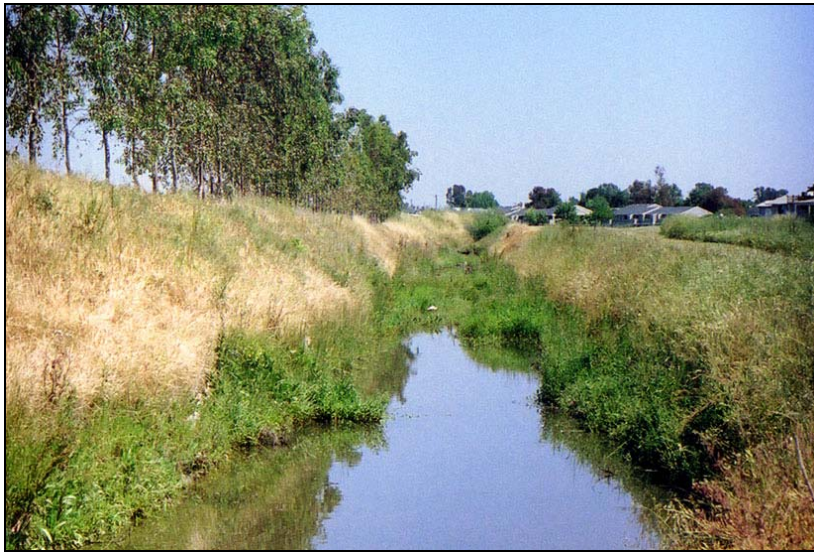
Figure 1 - Old, channelized section of Robla Creek prior to construction of RLCCA

In the 1970s, a reach of Robla Creek between Dry Creek Road and the Sacramento Northern Bike Trail was relocated to facilitate the construction of the Bell Aqua housing development and three water ski lakes. This channelized section of Robla Creek was restricted to a very narrow corridor that contained low-quality habitat and did not provide adequate room for flood flows (Figure 1).

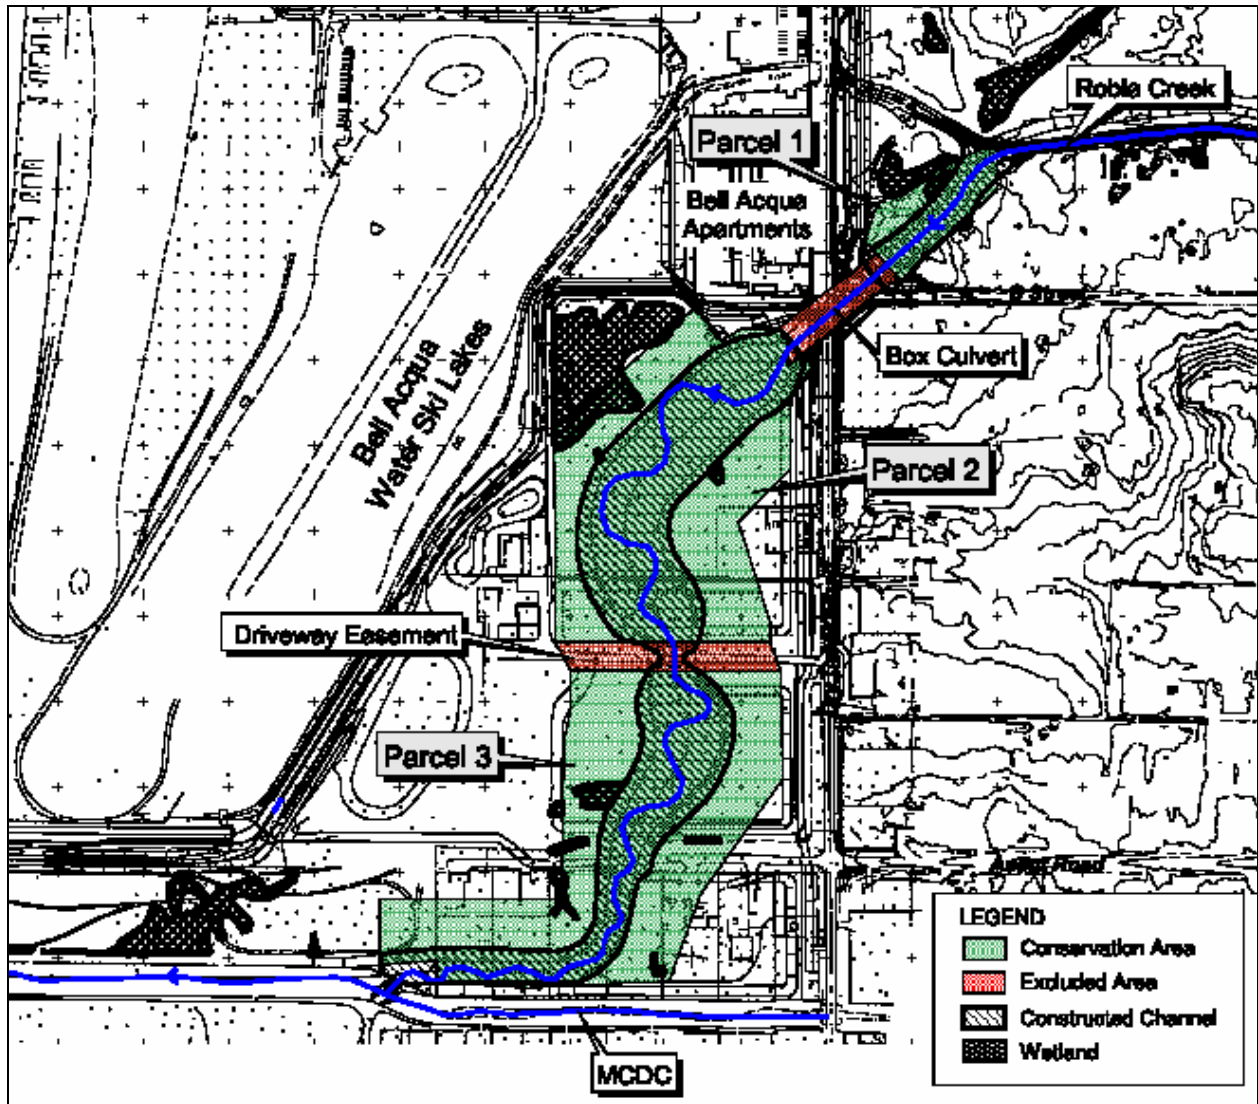
Figure 4 - Limits of the Rio Linda Creek Conservation Area.

The RLCCA comprises three parcels that total approximately 16.2 acres and includes the newly created section of Rio Linda Creek and adjacent uplands. Figure 4 depicts the limits of the RLCCA. The new Rio Linda Creek channel incorporates features that make it environmentally superior to the previously channelized portion of the creek. Habitat features of the new channel were specifically chosen to meet GGS requirements, but also are beneficial for many other wildlife species. Planting of sparse woody vegetation allows open canopy areas for GGS basking while providing access for clearing of debris for flood capacity maintenance. The design for the new channel was developed based on both historical and recent data on soils, hydrology, and vegetation conditions. The created channel incorporates in-channel freshwater marsh, seasonal wetlands/oxbow pools in the low floodplain, and riparian savannah in the floodplain and along its banks. The upland areas adjacent to the created stream channel are open grassland fields with scattered seasonal wetlands and vernal pools that existed prior to implementation of the Mitigation Project.

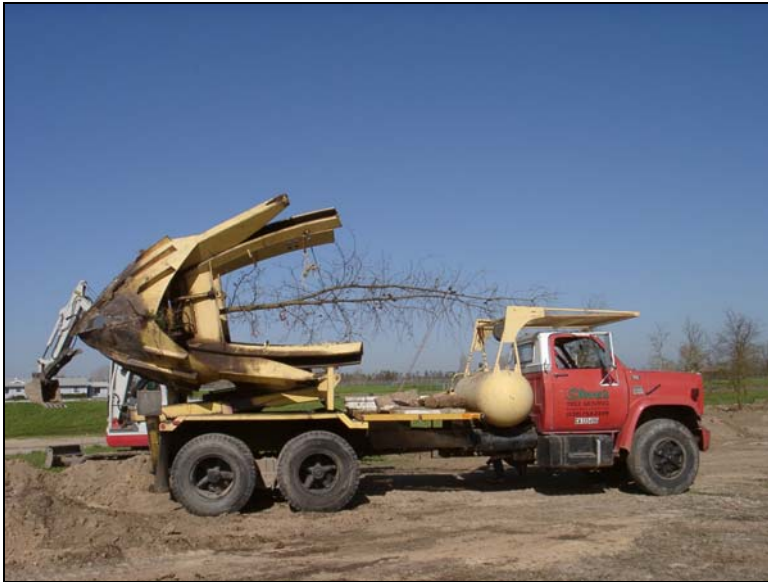
Figure 5 - Oak tree being transplanted to RLCCA.

A number of young oak trees were transplanted to the terrace outside of the flood channel in February 2003 (Figure 5). These trees were removed from the Rio Linda airport to resolve aeronautical safety concerns. They are being irrigated and maintained as part of the restoration of the RLCCA.
