Draft Vegetation Variance Request Natomas Levee Improvement Program Supplemental Appendix H – Preliminary Data and Analysis of Tree Fall in the California Central Valley

**By Chris J. Peterson
16 March, 2010**

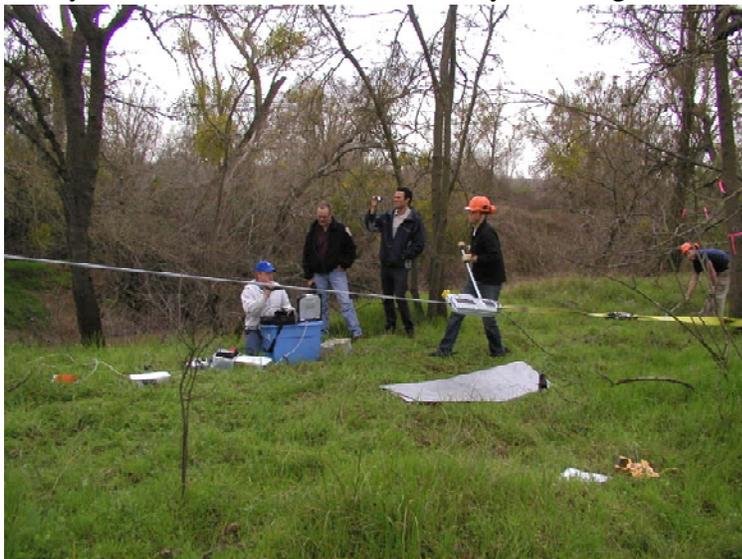
progress. The first photo shows winching, cable attachment to the anchor tree, and Peterson seated by the field computer that recorded the cable strain and tree tilt from electronic instruments.

of Water Resources and Sacramento Area Flood Control Agency, with support and cooperation from several other state and federal agencies. The goal of this study (it will be continued in January and February 2011) is to determine the relative stability of levee trees to windthrow. The approach taken is called 'static winching' and consists of attaching a winch and steel cable to a tree, pulling until the tree breaks or uproots, and in the process measuring the force generated by the winch. Photos in this section show this research in

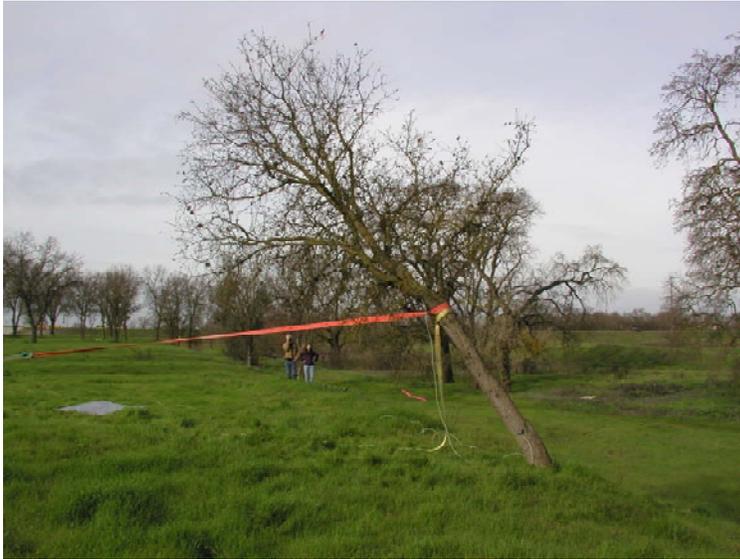
study species were primarily *Quercus lobata* (valley oak) and *Populus fremontii* (Fremont cottonwood). A few *Acer negundo* (boxelder) were also included. Winched trees ranged in size from 4 inches to 20 inches in trunk diameter. The majority of trees were located on levee slopes, but for the purposes of comparison, some trees located on floodplains next to levee slopes were also winched. Photo at left shows a valley oak at the Bear River study site, part-way through the winching process. For all trees considered

together, the average size was 11.0 inches diameter; trees on the floodplains were slightly larger (levee slope trees had average sizes of 10.2 inches diameter). Each tree was fitted with two inclinometers (“tilt meters”) that measured the tilt simultaneously with the measurement of cable strain by a load cell inline with the steel cable. Both of these instruments fed their output directly into a laptop computer at the study site.

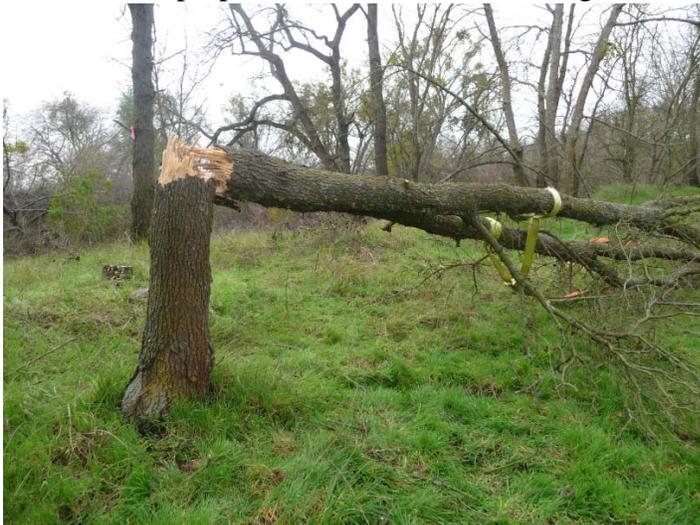
concern is with the potential impacts of tree uprooting on levee integrity, oaks and cottonwoods are of less concern because they are less likely to uproot, compared to boxelders. Future research will examine other species, such as willows. The photo at left shows the result of trunk breakage.

Findings included 26 trees that experienced trunk breakage, and 23 that uprooted. Almost all of the trees on the floodplains uprooted. If the nine uproots from floodplains are removed, the proportions are 26 trunk breakage and 14 uprooted of the trees on the levee slopes

proper. The breakage and uprooting data yield several preliminary conclusions: on levee slopes, winched trees were almost twice as likely to break rather than uproot, so for a given probability that a levee tree might be toppled by high winds, it appears that perhaps 2/3 may break off rather than uproot. Oaks on levee slopes were roughly evenly distributed between trunk breakage and uprooting; cottonwoods on levee slopes almost always had trunk breakage; while boxelders almost always uprooted. These patterns suggest that when

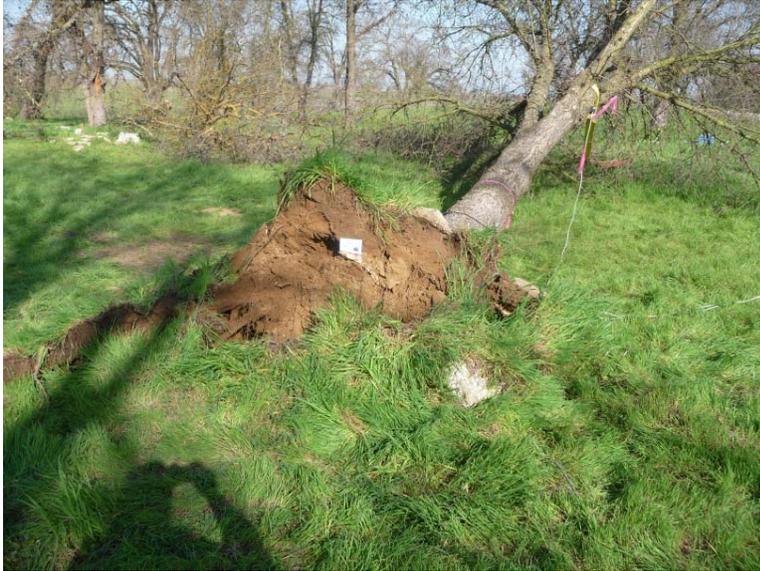
Uprooting occurred in a total of 23 trees, 14 of which were on levee slopes. Of these levee slope trees, the root pit created by uprooting was on average 4.1 feet x 2.9 feet, for an

average area of 10.6 square feet. The trees on floodplains created larger root pits (data not shown here), probably because they were slightly larger. Root pit areas were significantly positively correlated with tree size (diameter; $p = 0.035$, $r = 0.56$). Root pits for levee slope trees had mean depths of 1.62 feet; maximum recorded depth was 3.5 feet for levee slope trees that uprooted. Root pit depth was significantly positively correlated with tree diameter.
