Lower American River Project Year 5

Mitigation Monitoring Report

Bank Protection Sites 1-5, and Offsite Mitigation Areas

at RM 0.9R, RM 3.3R, 11.6R

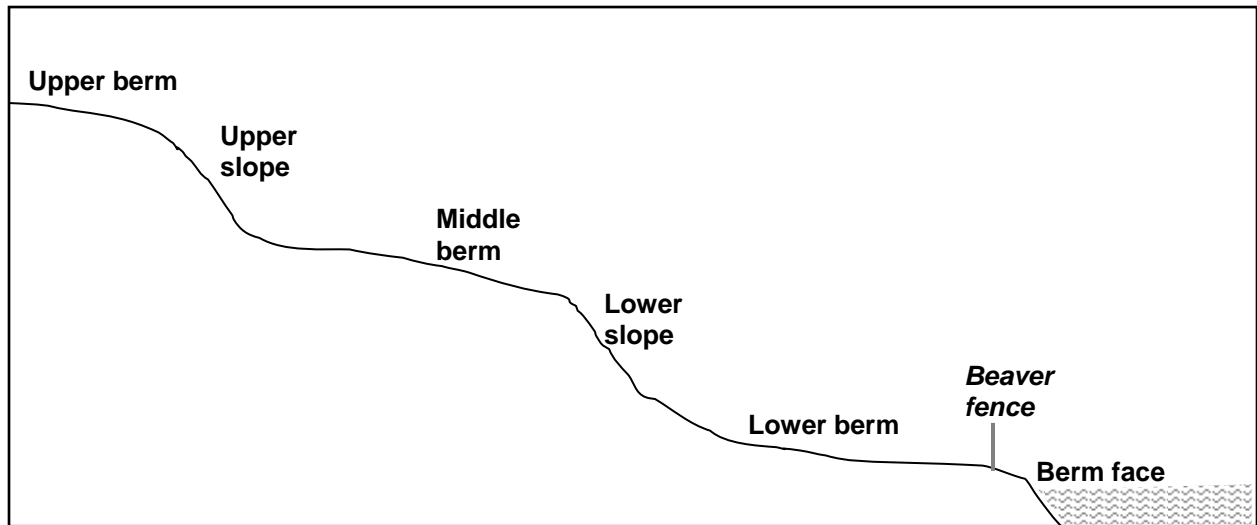
Figure 2. Generalized cross section of mitigation sites and planting surfaces

Bank protection construction resulted in the loss of riparian, shaded riverine aquatic (SRA), and special-status species habitat. Several mitigation measures were incorporated into project designs. Site designs include a variety of surfaces capable of supporting vegetation; low riverside berms (small constructed floodplains) with varying berm-surface elevations and shoreline configuration; and woody materials submerged in constructed embayments or smaller bank scallops. Native woody and herbaceous riparian vegetation was planted on revetment at Sites 1-5 (including a low-berm face, low berm, lower slope, upper slope, and middle berm) with the goal of creating a self-sustaining, mixed canopy riparian forest and riparian scrub habitat, SRA habitat, and valley elderberry longhorn beetle (VELB) habitat. An illustration depicting a generalized cross section of mitigation sites and the terms used to describe planting surfaces is located in Figure 2.
