VEGETATION VARIANCE REQUEST

Natomas Levee Improvement Program

**Sacramento Area Flood Control Agency
1007 7th Street, 7th Floor
Sacramento, CA 95814**

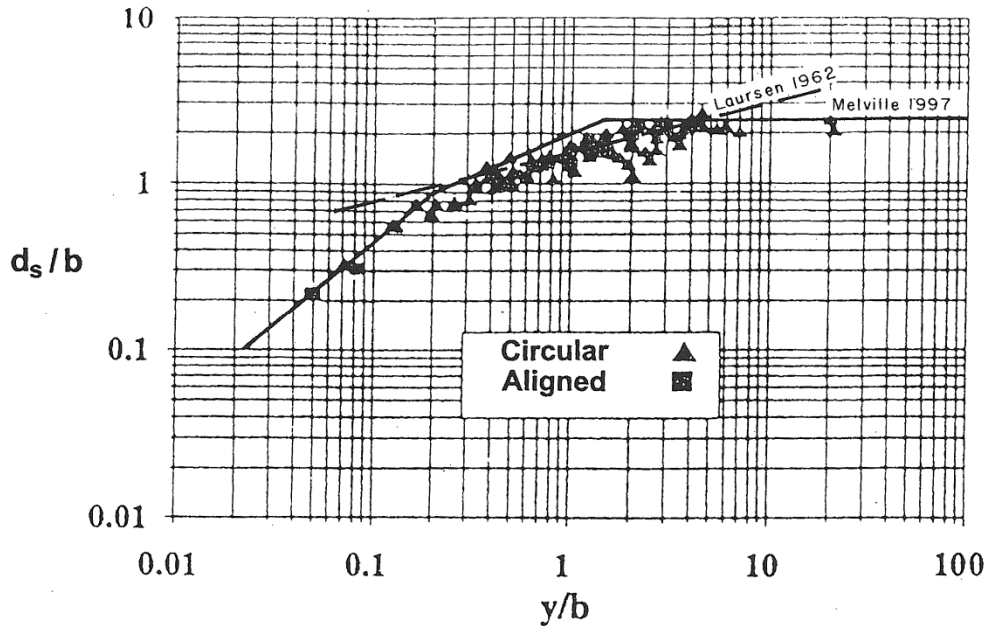
Figure 5-1: Basic Local Scour Relationship for Aligned or Circular Piers

Figure 5-1 (refer to curve labeled Melville 1997) shows that when the flow depth is much greater than the pier width that the maximum scour depth tends to be a constant ratio of the pier width. For very shallow depths, the maximum scour depth goes to a very small portion of the pier width, or to zero. For intermediate depth to pier width ratios, which often occur around the root plates of fallen trees on the levee slope, the maximum scour depth is a function of both pier width and flow depth. The Melville and Coleman (2000) equations are described in detail in **Appendix F**. Velocity becomes important in determining if scour will occur and the time it takes for the scour hole to reach maximum or equilibrium depth.

Pier scour equations are generally empirical equations based on physical modeling of scour around different pier dimensions and shapes in non-cohesive bed materials. A number of different equations have been recommended or developed by different organizations but most equations rely on predicting the depth of scour from local flow depth and pier width, then adjusting this prediction for other factors. As an example, Figure 5-1 shows the basic relationship between the ratio of scour depth (d_s) to pier width (b) and that of flow depth (y) to pier width (TAC 2004; their Figure 4-17).
